Forgotten Wrecks
of the
First World War

April
2018

SM U-90

Site Report

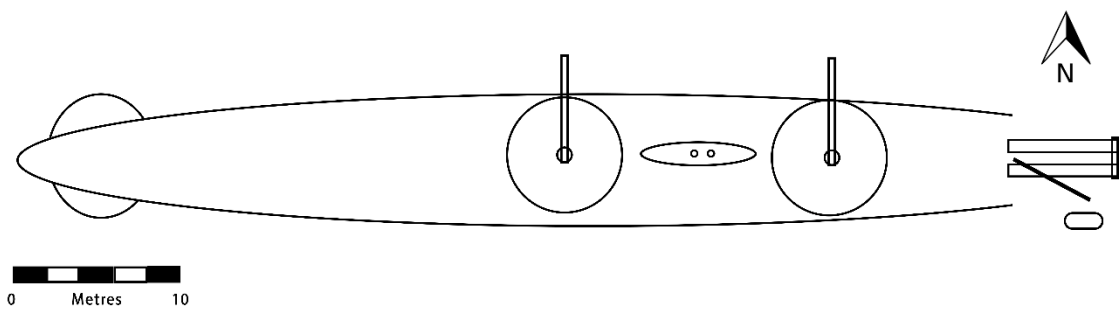
The dive team found the wreck to be well preserved, with the bows lying to the east (Figure 10), leaning over onto its starboard side at an angle of approximately 45 degrees (Figure 11). A baseline tape measured the length of the wreck to be approximately 65m. See Appendix 8.1 for Dive Logs.

**Figure 10: Scale representation of seabed remains.
The U-boat leans to starboard at an angle of approximately 45 degrees.**

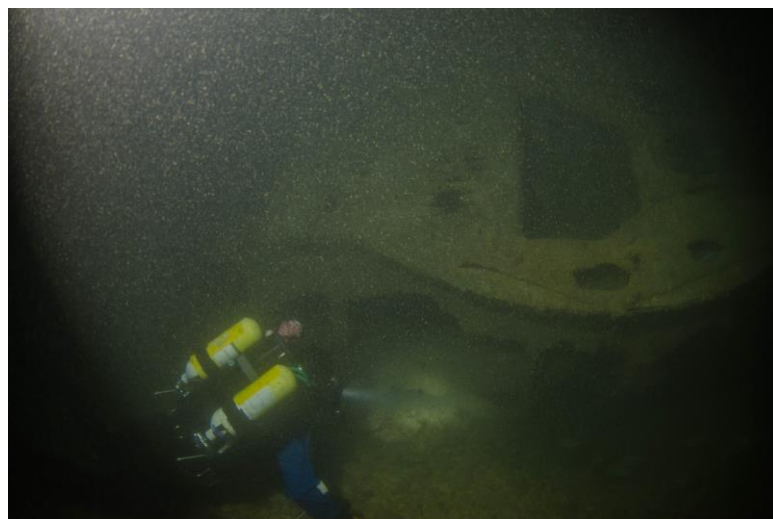
**Figure 11: Forward gun platform.
Diver at seabed level, starboard side, forward gun-platform, shining torch through outer-hull.
The submarine's 45 degree lean to starboard can be clearly seen.**

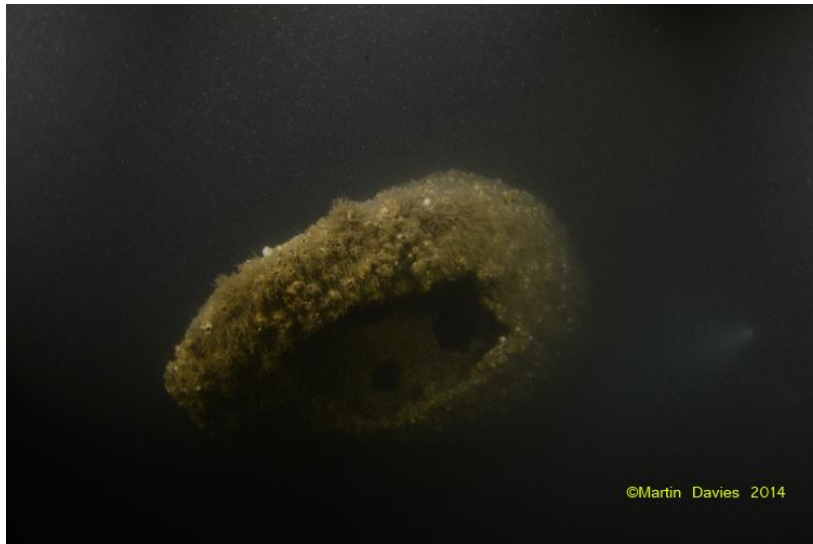
Figure 12: The stern from behind.

The stern of the U-boat lies to the west and is leaning to starboard at an angle of approximately 45-50 degrees (Figure 12).

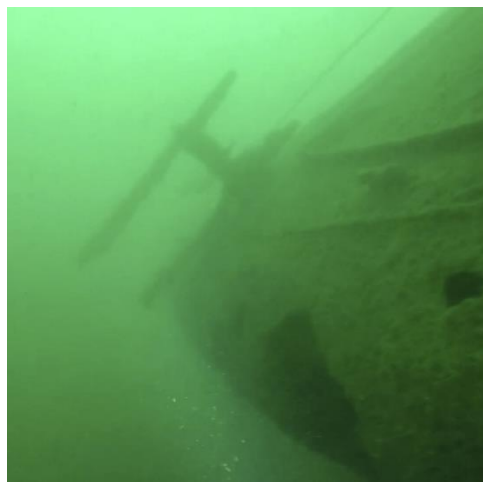
Figure 13: Stern with upper vertical rudder frame

On 11th July 2014, MAT divers observed a wooden element with iron sheathing buried in sand at the stern of the wreck. It is possible that this is part of the upper vertical rudder.

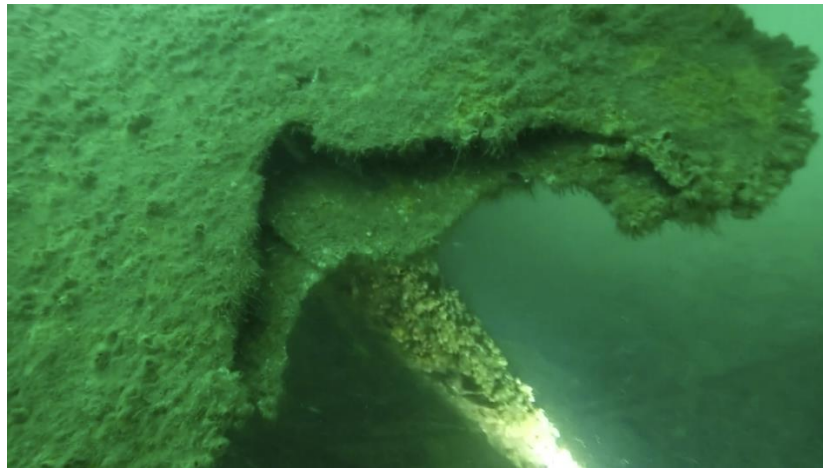
The trailing edge of the rudder is jagged and damaged revealing that the rudder is hollow (Figure 16).

Figure 16: Trailing edge of rudder
Image: Hamish Morrison

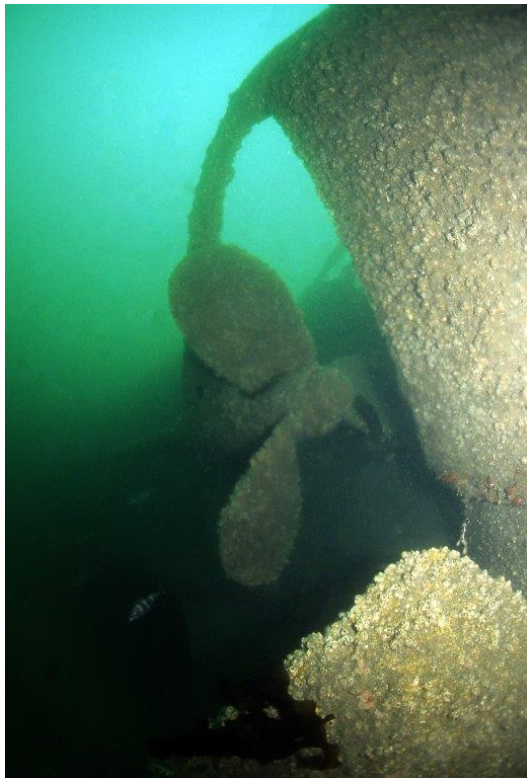
Both three-bladed propellers are still fitted to the propeller shafts on either side of the hull. The port propeller (Figure 17) is missing its cone, which is known to have been recovered by divers in the 1980s and is currently in private ownership in Chichester. The boss of the port propeller was found to have the same markings as those on the cone, i.e. **D. 90. B.B.** (see Figure 54 & 55 and Section 5.2 for meaning). The starboard propeller (Figure 18), with cone *in situ* is underneath the hull, which leans to starboard.

Figure 17: Port propeller (note the missing cone) and aft hydroplane.
Bottom right: the lower leading edge of the rudder can be seen.

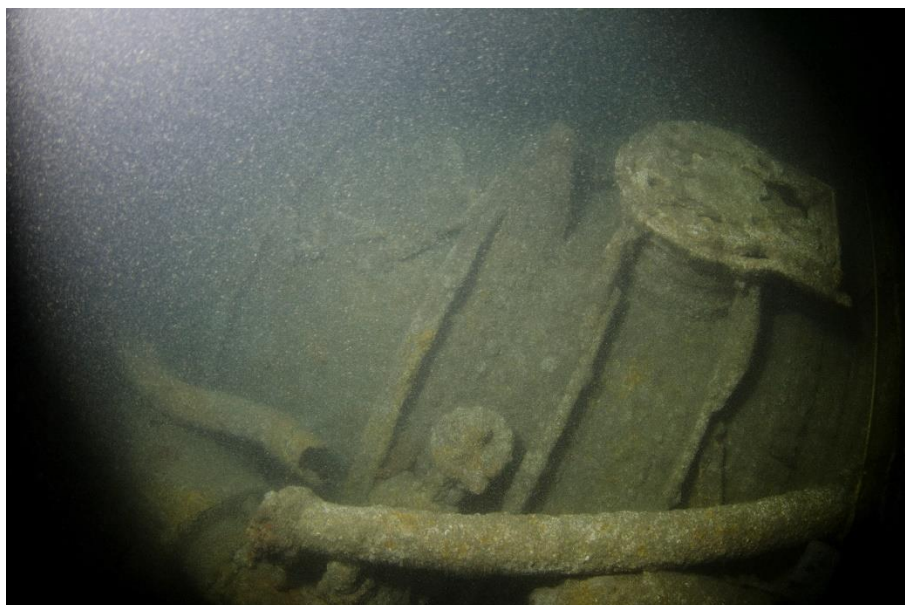
Continuing forwards there is a break in the outer hull and the pressure hull of the submarine can be seen (Figure 22). It is well preserved and the riveted construction and externally fitted frames (see Section 3.1) can clearly be seen.

**Figure 22: Pressure hull.
With riveted construction, external frames.**

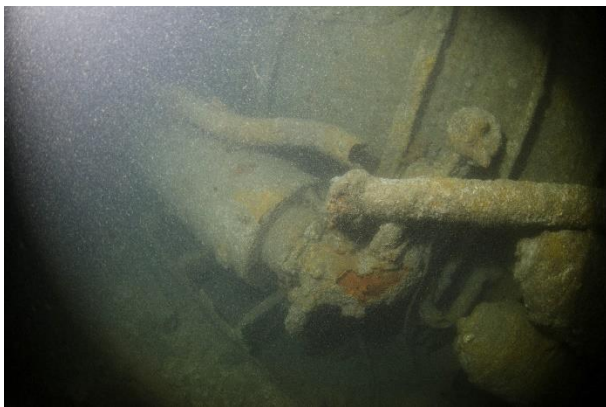
At the forward end of the hydraulic ram, where it penetrates the pressure hull, an area of concretion has been knocked away causing fresh corrosion (Figure 24). It is not clear if this was the result of deliberate or accidental activity but the damage must have taken place between July 2015 (Figure 25) and July 2017.

Figure 24: Forward end of hydraulic ram (July 2017)

While the present condition of U-90 is good, concern has been raised following the publication of the wreck's position in a diving magazine in December 2014. Damage to the site, sustained between 2015 and 2017 has been observed (see Figure 24 & 25).

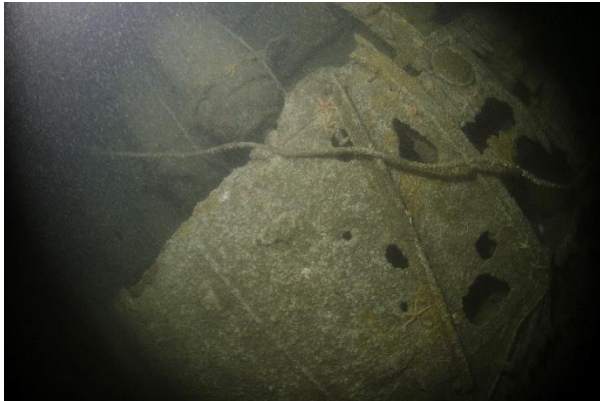
Compared to other First World War U-boat wrecks, the submarine's outer casing is in relatively good condition (Figure 26 & 27).

Figure 26: Outer casing.

A section of hull, aft of the conning tower, where the outer casing is still intact.

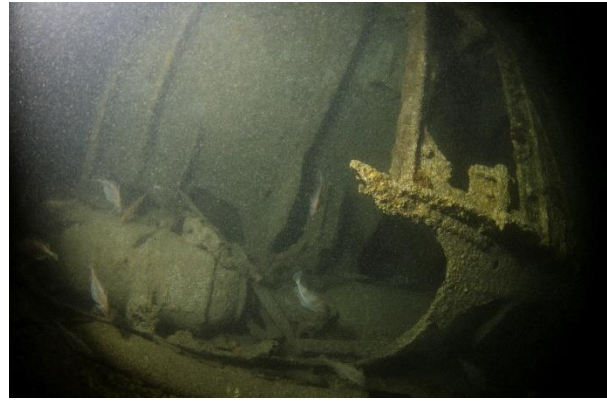
Figure 27: Pressure hull, outer casing and HP cylinder.

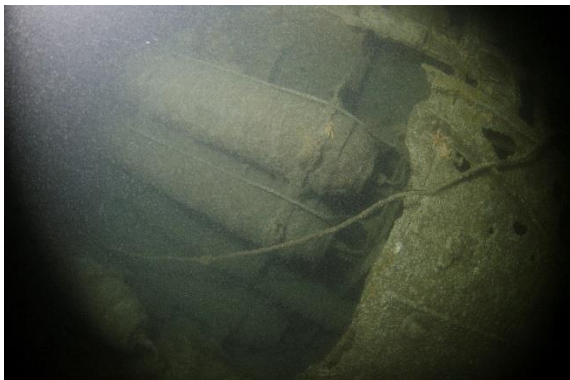
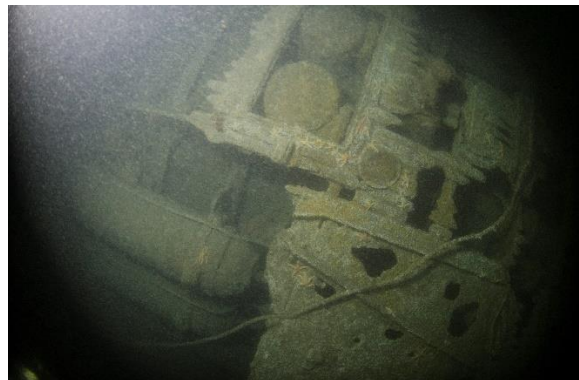
Figure 28: Pressure cylinders

Pressure cylinders can be seen all over the site, many still *in situ* between the pressure hull and outer casing (Figure 28) but a number have fallen from the wreck and lie on the seabed off the starboard side.

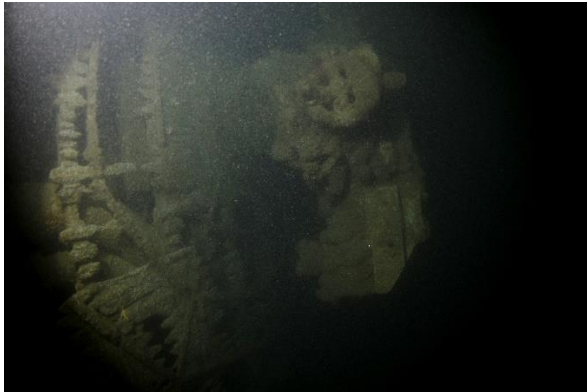
The wooden deck is well preserved in places, particularly in the area of the aft gun (Figure 29) and forward gun (Figure 30).

Figure 29: The aft gun platform with extant wooden deck planking

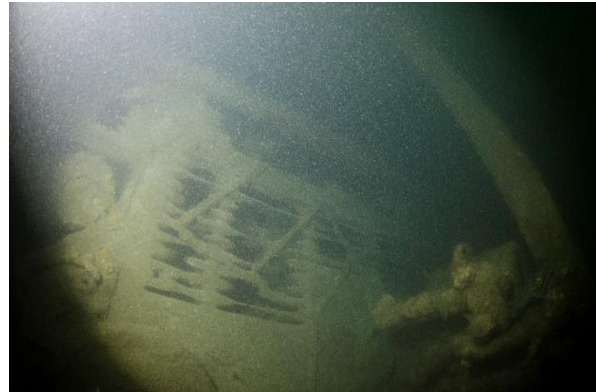
Figure 30: The forward gun platform with extant wooden deck planking

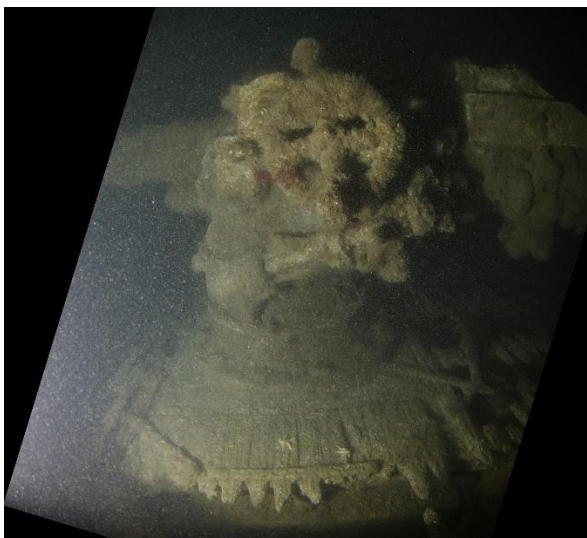
Figure 31: Aft gun on the wreck of U-90

The aft gun and its mount (Figure 31) are well preserved. While heavily concreted, the ranging wheels, hydraulics, breech block and top-mounted recoil cylinder can clearly be seen and both gun and mount appear to be a very good match for the U-boat gun at Ward Park, Bangor, Northern Ireland (Figure 32).

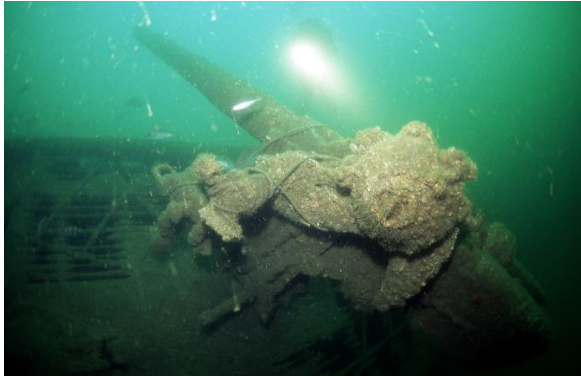
Like the aft gun, the forward gun on U-90 is *in situ* on its mounting and platform, pointing upwards towards the surface. The sighting and adjustment mechanisms are heavily concreted but it is still possible to make out the original form.

Figure 34: Forward gun on wreck of U-90
Image: Martin Davies.

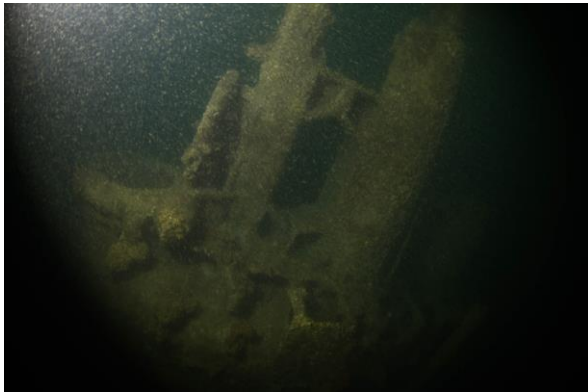
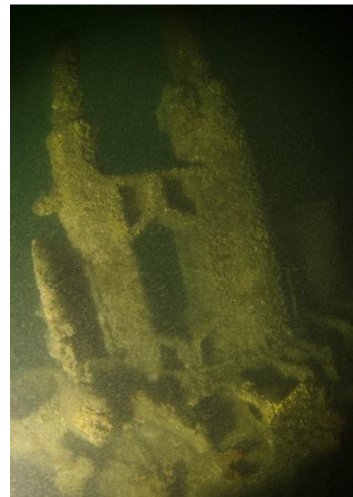
Between the guns, the conning tower (Figure 39 & 40) is the highest part of the wreck at a depth of around 33m and is relatively intact. The aft hatch of the conning tower is open, inside a ladder can be seen on the starboard side.

Figure 39: Upper conning tower.
Viewed from the starboard side.

Left to right: hatch (open), navigating periscope, attack periscope.

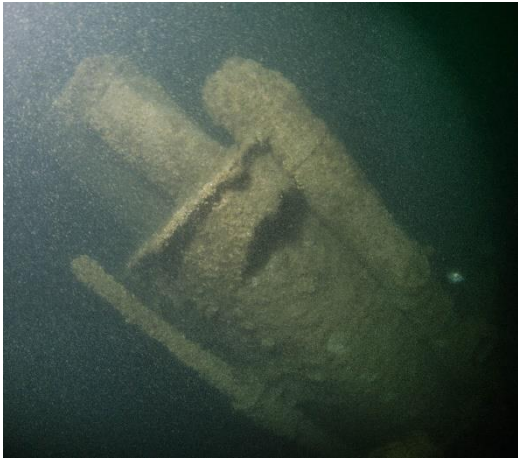
Figure 41: the front of U-90's conning tower

The front of the conning tower on the wreck thought to be U-90 (Figure 41) is well preserved and an excellent match for that seen in one of the photographs in Fischdick's book (Figure 42).
