Forgotten Wrecks
of the
First World War

April
2018

SM U-90

Site Report

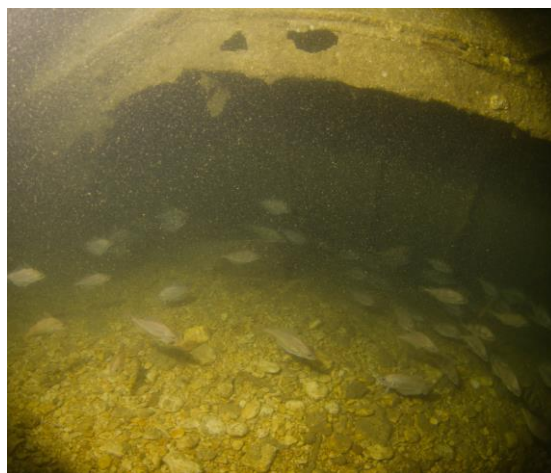
The wreck is at a depth of 33-39m on a sand and shingle seabed (Figure 8). Marine life is abundant, with star fish (see Figure 21), conger eels and pouting being particularly common.

Figure 8: Seabed and marine life of the wreck of U-90

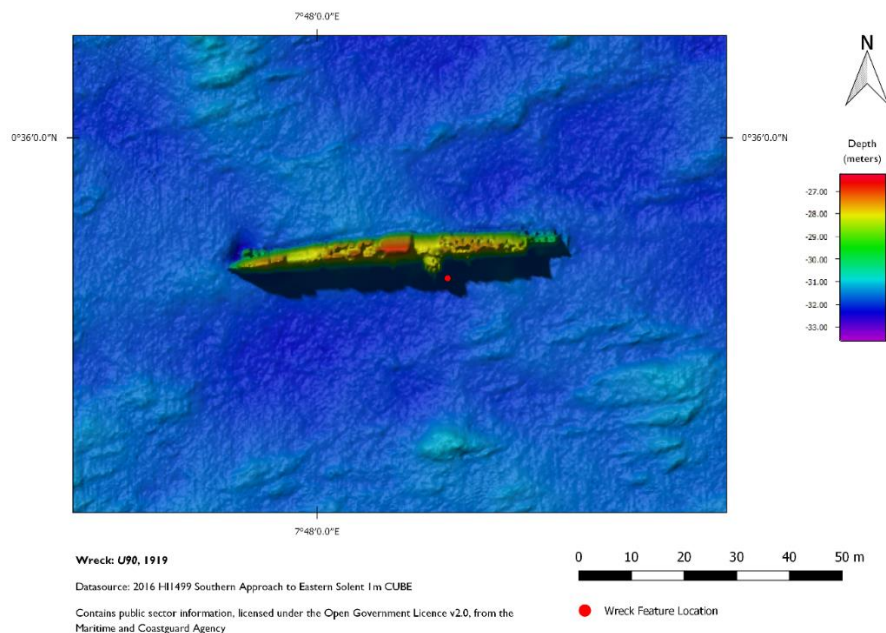
Figure 9: Bathymetry of the wreck of U-90

The bathymetry shows the wreck of a submarine, measuring approximately 63m in length, with bows to the east and stern to the west. It is largely intact, though a 6m long section of outer hull and superstructure at the bow is missing. Here, the forward torpedo tubes are recognisable and some unidentified upstanding structure. The wreck is leaning to starboard on a relatively flat and level seabed, with signs of scouring at the port stern, where the port propeller and hydroplane can be seen. The conning tower and parts of at least one periscope are apparent, as well as the forward and aft guns. A section of the port side in the area of the aft gun seems particularly intact. From the stern to the centre of the conning tower measures just under 39m, from the centre of the conning tower to the bow, just under 25m, demonstrating that the conning tower is forward of amidships, as expected for a Type U-87 U-boat.

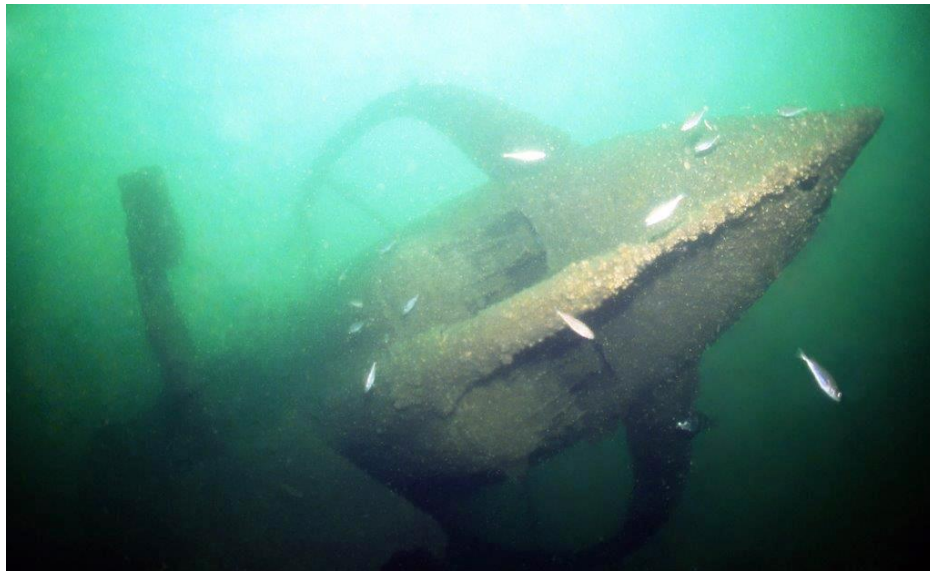
The lower vertical rudder is still *in situ* underneath the hull. The foot is intact and rests on the seabed aft of and between the two aft hydroplanes. Immediately above the rudder is the keel of the U-boat

and the two closed torpedo tubes. The aft hydroplane guards can be seen above and the port aft hydroplane can be seen protruding to the left of Figure 14.

Figure 14: Stern of U-90.

Looking up from underneath the stern, the two closed torpedo tubes can be seen, the aft hydroplane guards, the rudder (bottom left) and the port aft hydroplane.

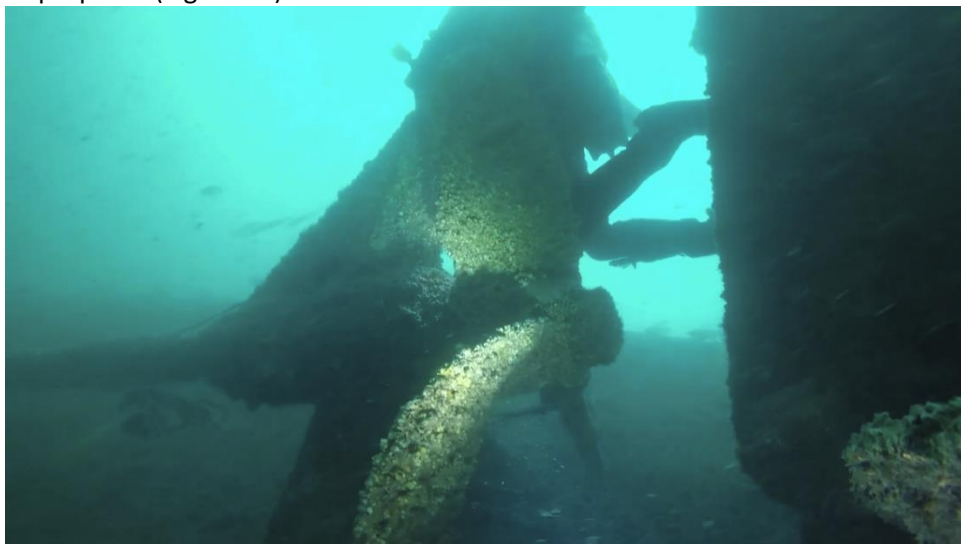
Figure 15: Port propeller.

Left to right: port propeller shaft, propeller, hydroplane.
The bottom leading corner of the rudder can be seen bottom right.

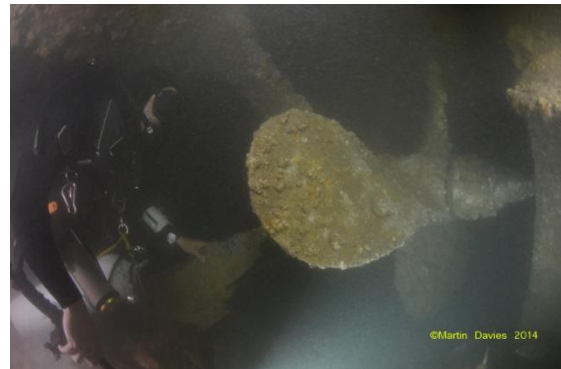
Both three-bladed propellers are still fitted to the propeller shafts on either side of the hull. The port propeller (Figure 17) is missing its cone, which is known to have been recovered by divers in the 1980s and is currently in private ownership in Chichester. The boss of the port propeller was found to have the same markings as those on the cone, i.e. **D. 90. B.B.** (see Figure 54 & 55 and Section 5.2 for meaning). The starboard propeller (Figure 18), with cone *in situ* is underneath the hull, which leans to starboard.

Figure 18: Starboard propeller (with cone and aft hydroplane)

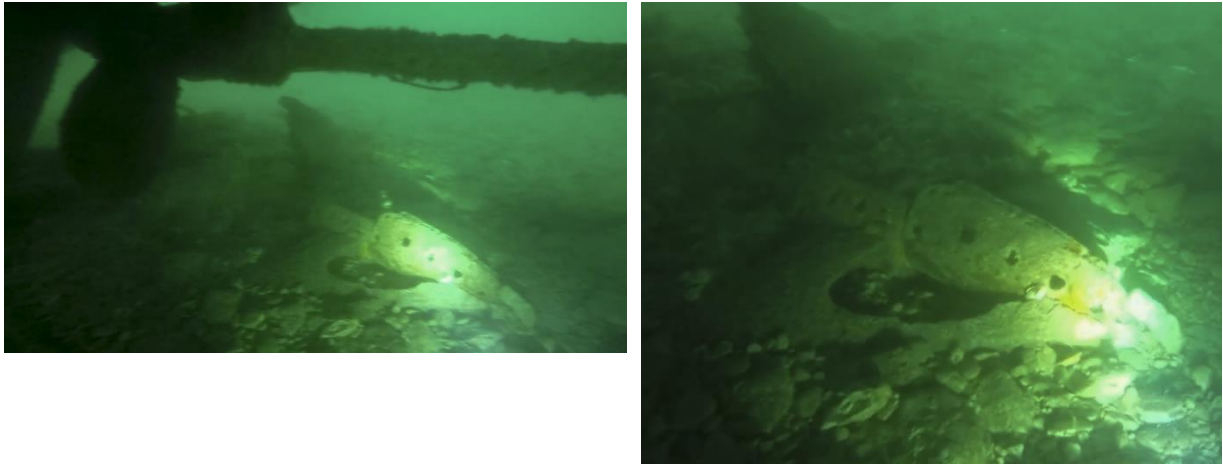
Beneath and slightly forward of the starboard propeller, an unidentified metal feature lies on the seabed underneath the prop shaft (Figure 19).

Figure 19: Unidentified metal feature underneath starboard propeller.
Image: Hamish Morrison

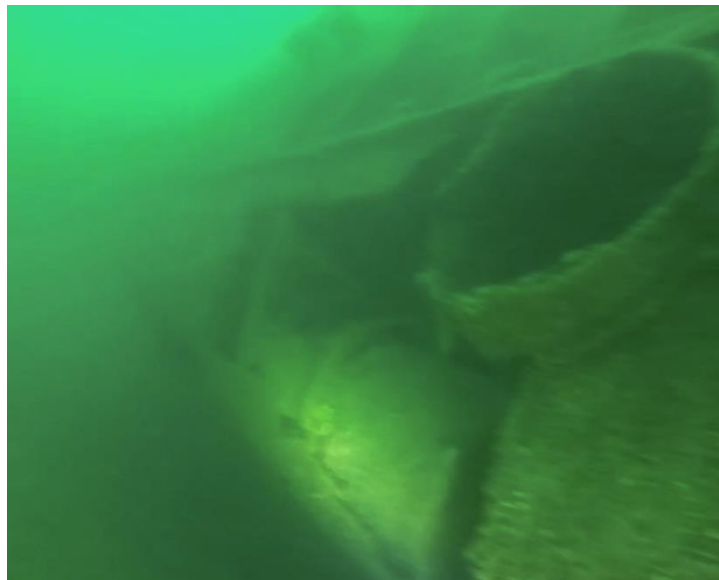
Continuing forward, the outer hull and deck is well preserved and two deck mooring bollards can be seen, one behind the other, in the centre of the deck. Forward of this, a circular deck hatch can be seen in the starboard side (Figure 20).

Figure 20: Aft circular deck hatch (starboard aft).
Fixed deck bollards can just be seen centre top.
Image: Hamish Morrison

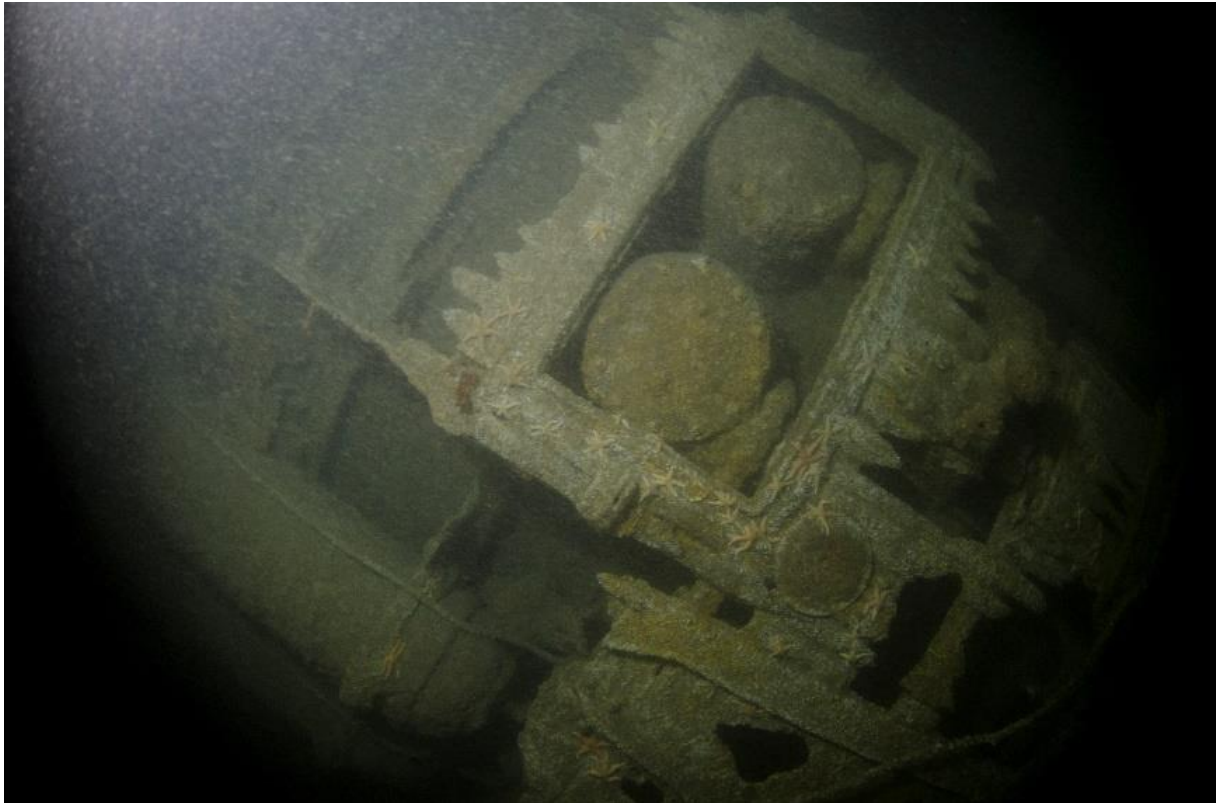
Slightly further forward (between the stern and the aft gun platform) a rectangular opening/hatch can be seen in the wooden decking (Figure 21). This appears to be for retractable mooring bollards.

Figure 21: Retractable mooring bollards

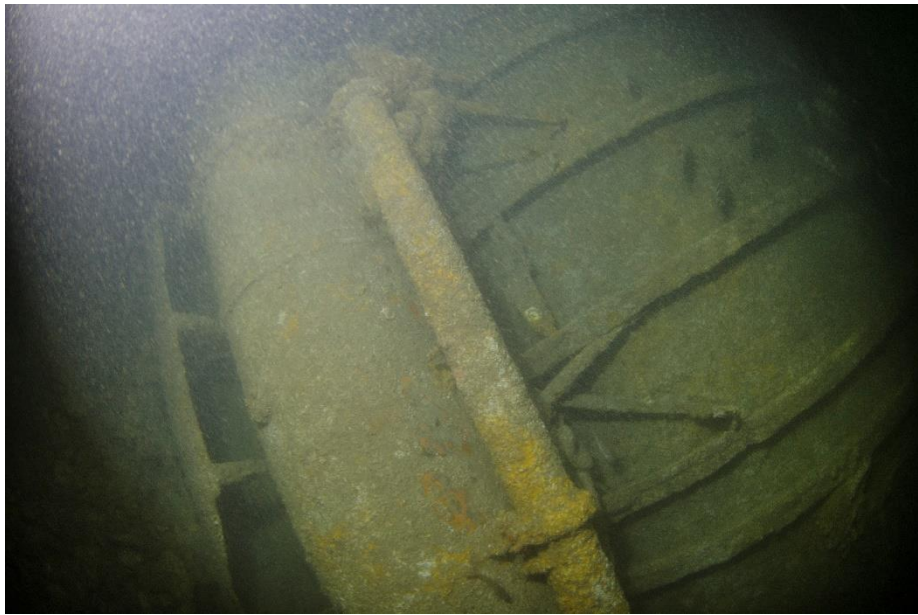
The absence of outer hull in this area enables a good view of the hydraulic ram, which would have operated the rudder. This runs down the starboard side, between the pressure and outer hull, just under the deck (no longer present) (Figure 23).

Figure 23: Hydraulic ram (starboard side, between pressure and outer hull)

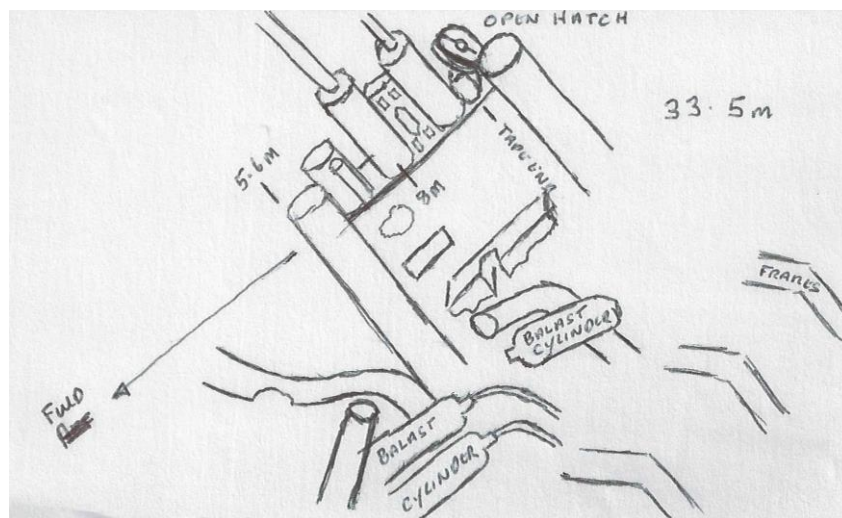
Between the guns, the conning tower (Figure 39 & 40) is the highest part of the wreck at a depth of around 33m and is relatively intact. The aft hatch of the conning tower is open, inside a ladder can be seen on the starboard side.

Figure 40: Sketch of upper conning tower from port side (Mark Hobbs)

There are only two periscopes, as expected for U-90 (see Section 3.1). The attack (forward) periscope is the longer of the two, the upper part of the navigating (aft) periscope is at the Shipwreck Centre & Maritime Museum, Isle of Wight (see Section 5).

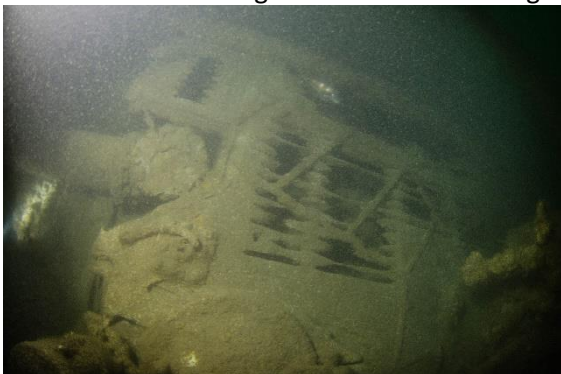
Forward of the conning tower is the forward gun platform (Figure 43).

Figure 43: Forward gun platform.
Hatchway can be seen at the bottom centre of the photo

The hatch on the forward gun platform and in the top of the conning tower (see Figure 39) are dished, as expected for U-90 (see Section 3.1). The wooden decking and metal framework of the deck on the wreck of U-90 (Figure 43) match those shown in Fischdick's photographs (e.g. Figure 44).

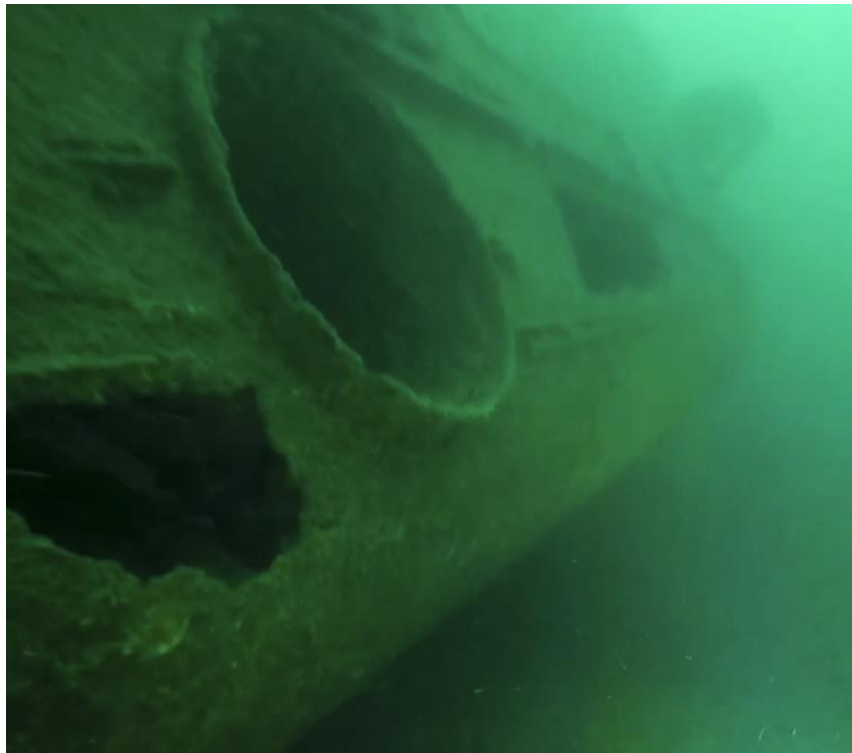
Moving forward from the forward gun platform, a number of rectangular hatchways can be seen in the decking before a forward circular hatch is found on the starboard side (Figure 45).

Figure 45: Forward circular starboard hatch
Image: Hamish Morrison

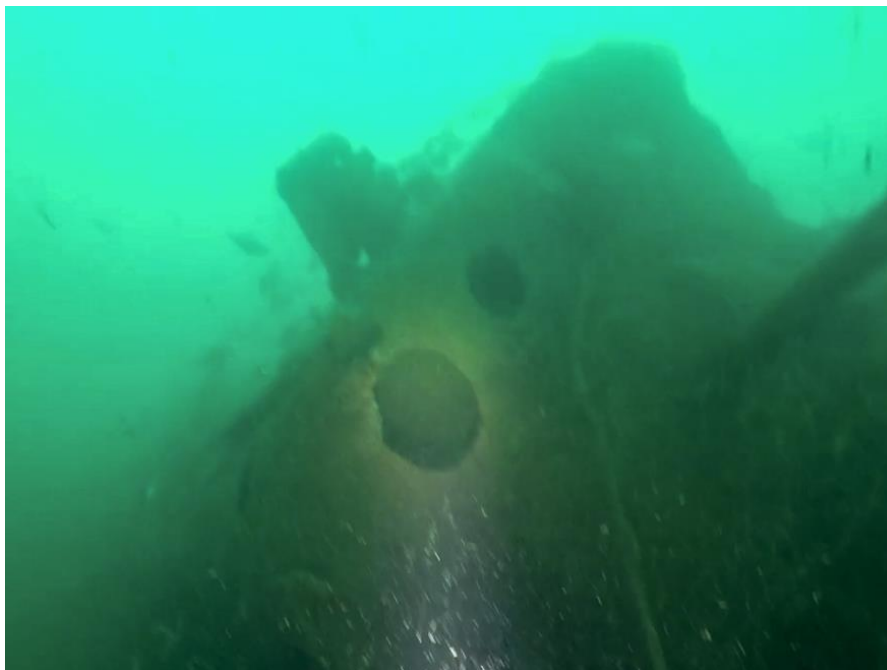
The outer hull ends at the forward end of the pressure hull, the anchor windless appears to be *in situ* on the deck above (Figure 46).

Figure 46: Forward end of the pressure hull, anchor windless on deck
Image: Hamish Morrison

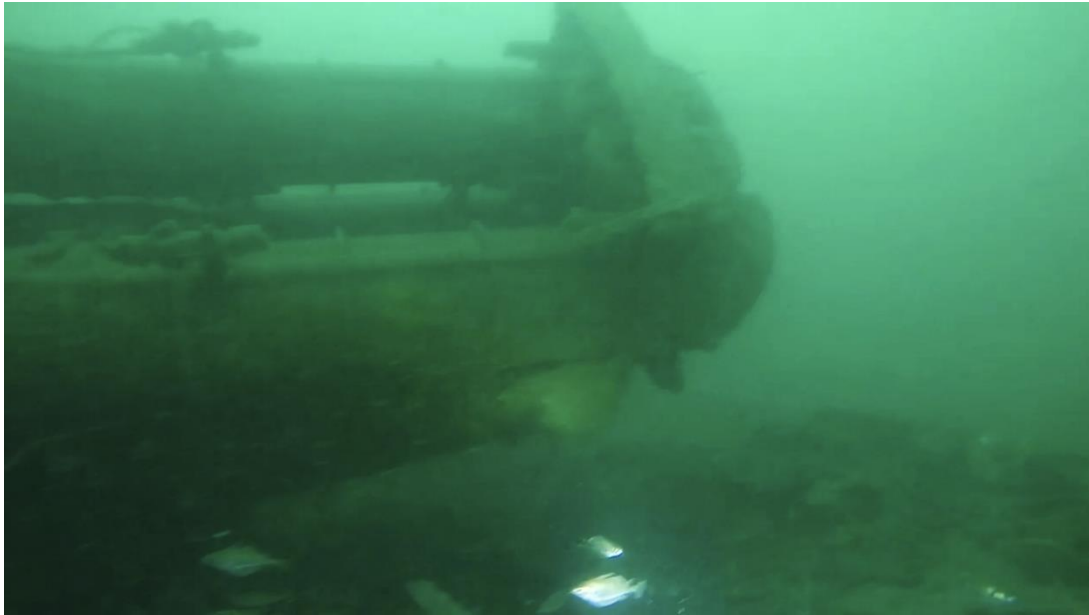
The four bow torpedo tubes protrude from the front of the pressure hull (Figure 47), along with a pivoting davit/arm (Figure 48) for manoeuvring the anchor. In most First World War U-boats, this mechanism comes out of the top of the pressure hull, the Type U-87 (and Type U-43) submarines were unusual in that the arm/davit came out of the front of the pressure hull.

Figure 47: The 4 bow torpedo tubes
Image: Hamish Morrison

In July 2014, divers reported seeing the forward hydroplanes lying flat on the seabed on either side of the hull towards the bow. A lot of structure, fixtures and fittings lie on the seabed in a debris field around the bow torpedo tubes (Figure 47).

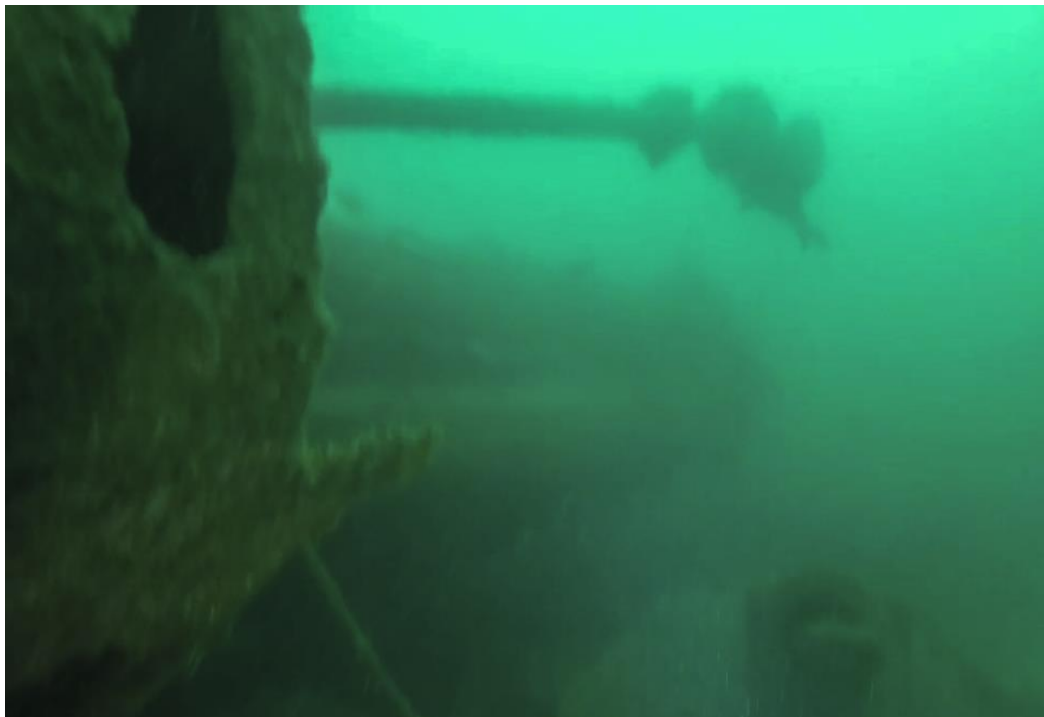
Figure 48: End of pressure hull, with protruding bow torpedo tubes (below) and anchor davit/arm (above)
Image: Hamish Morrison

The starboard anchor pocket, complete with anchor, lies upside down on the seabed next to the front end of the pressure tube and below the anchor davit/arm (Figure 48 & 49).

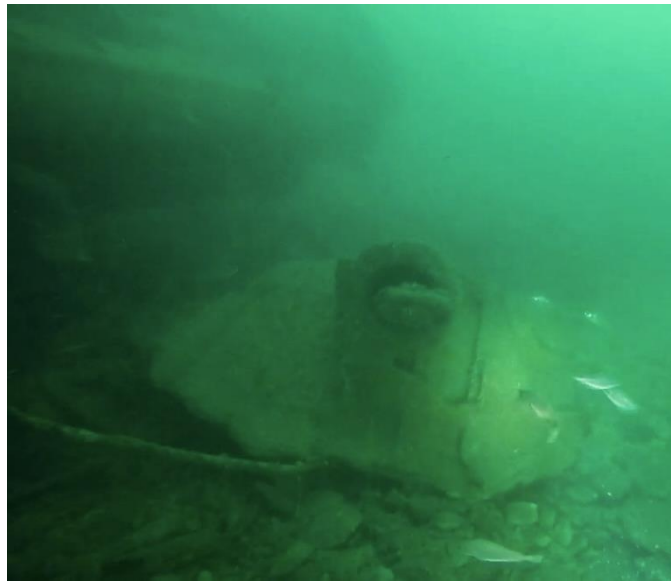
Figure 49: Starboard anchor pocket (upside down). Anchor ring and top of shank can be seen
Image: Hamish Morrison

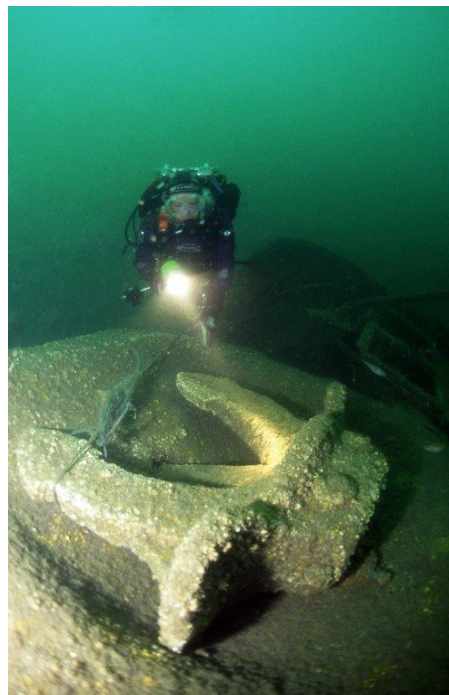
Figure 50: U-90's port anchor
Image: Martin Davies

In 2014, the port bow anchor was photographed (Figure 50), the stockless anchor, closely resembling a Hall design, with curved flukes and a single crown pin, appears to be *in situ*, stowed in its anchor pocket. Some blue line can be seen tied around one of the flukes.

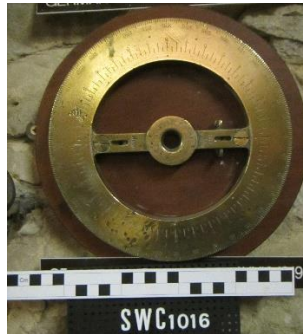
Figure 52: Compass ring

Diameter: 212mm
Thickness: 19mm
Brass
Markings: Compass graduations.
VORN STEIGER 1736 (each side of central hole)

These three artefacts (Figure 51 to 53) were recovered in June 1988 from the seabed at the base of the conning tower, on the starboard side, below the periscopes (Martin Woodward 2018, pers. comm., 3 January).

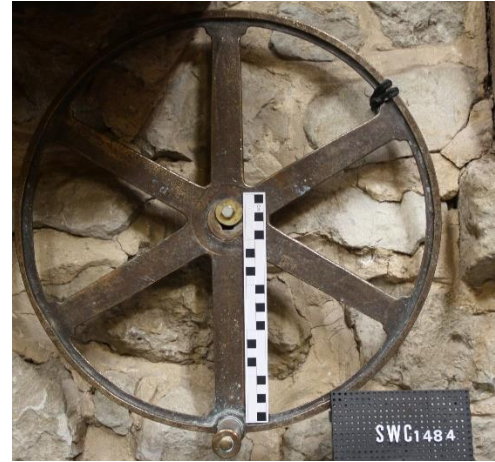
Figure 53: Brass wheel believed to be steering wheel from conning tower

Diameter: 460mm
Brass

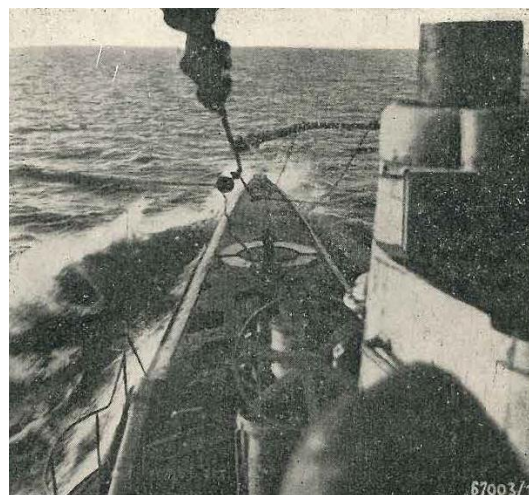
Figure 54: U-90 at sea (Fischdick 1937: 45)

U-90's conning tower steering wheel can be seen *in situ* in one of the photograph in submariner Arnold Fischdick's book (Figure 54).

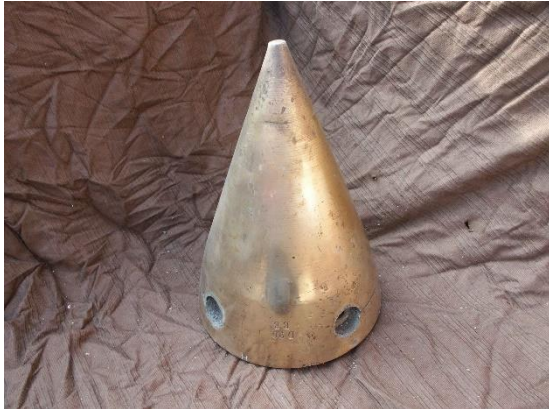
Figure 55: Propeller cone recovered from U-90
Image: Martin Woodward

Another object recovered from U-90 is known to be in a private collection in Chichester. Though it was not possible to record this item, photographs (Figure 55 & 56) were kindly provided:

Though a photograph of the propeller cone was obtained (Figure 55), it was not possible to access the artefact during the project to record dimensions and other details. It is hoped that this can be achieved in the future. No other known examples of propeller cones from U-boats built in Danzig are known of, making it a particularly important example.

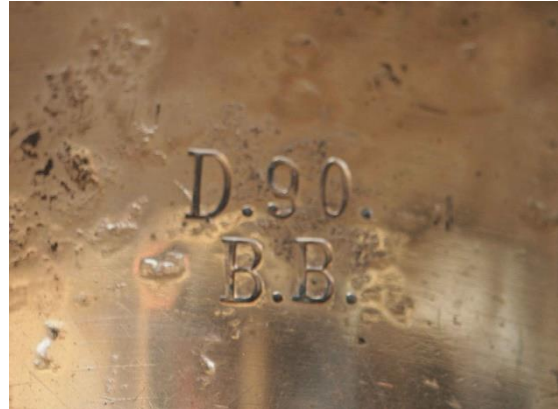
Figure 56: Markings on propeller cone

Propeller cone embossed with: D. 90. B.B.:

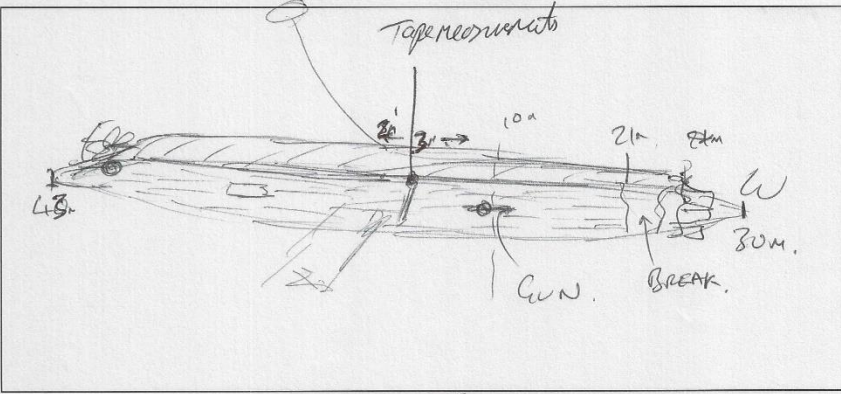
Outcome/ procedures
<i>Tape measure laid to bow and stern. Patient features recorded. Submarine in the order of 69-70m long.</i>

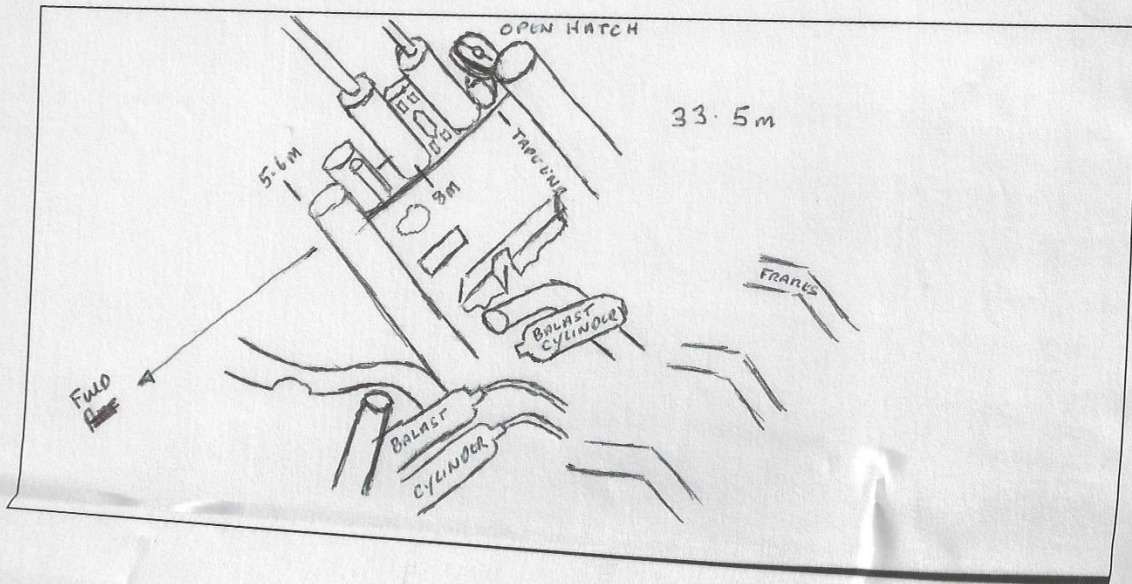
Outcome/ procedures
<i>lots of structure visible eg sky periscope, normal periscope, radio mast. Structure of surrounding missing but frames visible. 3 hp gas cylinders visible - has 45° angled side bows east.</i>

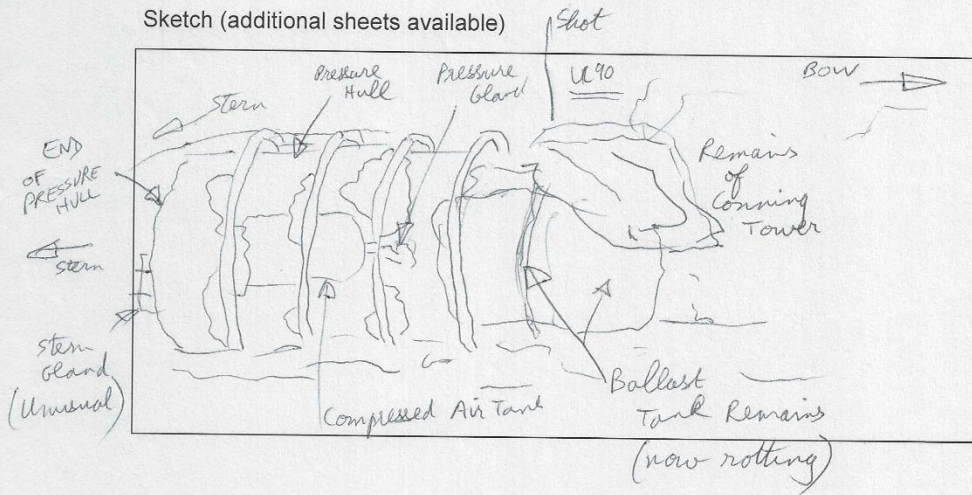
Outcome/ procedures
Reached the stern. Mark and Tare on the prop and so returned on Starboard side
Some interesting (early) technology such as glands, penetrations of the pressure hull) and the propeller stern gland
